Safety Alert

Ramp Agent Injury to Finger

05th May 2023

ASGrOps_SA_051

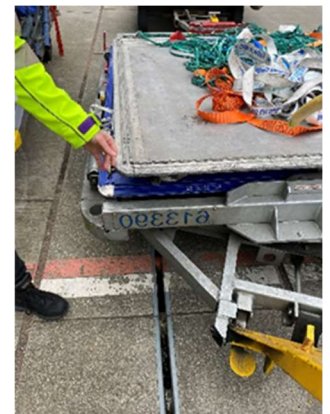
Two ramp agents were attempting to manoeuvre an empty PKC pallet on an LDL loader. The pallet was stuck between the edges of the platform because it is not uniformly square, one edge is slightly longer than the other. An investigation has been initiated, however at present it is understood that the two ramp agents needed to rotate it manually 90-degrees. In the process of rotating the pallet, the injured party's middle finger was caught underneath the pallet corner and the platform bed. This resulted in a severe injury to their finger.

- When handling loads, consider the risk from trapping or crushing body parts
- Ensure you follow your company's manual handling processes and procedures and if unsure, ask your supervisor
- When working with others, plan your work and communicate prior to undertaking tasks. Communication is critical during two-person activities
- Report close calls and unsafe acts via your company's reporting channels and through the Airport Community App.
